Inspection Report
For
1151 Ellen St.
Seattle, Washington

Commercial Inspection Report
For
1151 Ellen St.
Seattle, Washington

Date: November 19, 2011
Type of Property: Commercial Two Story Building
Weather: Overcast, Rain

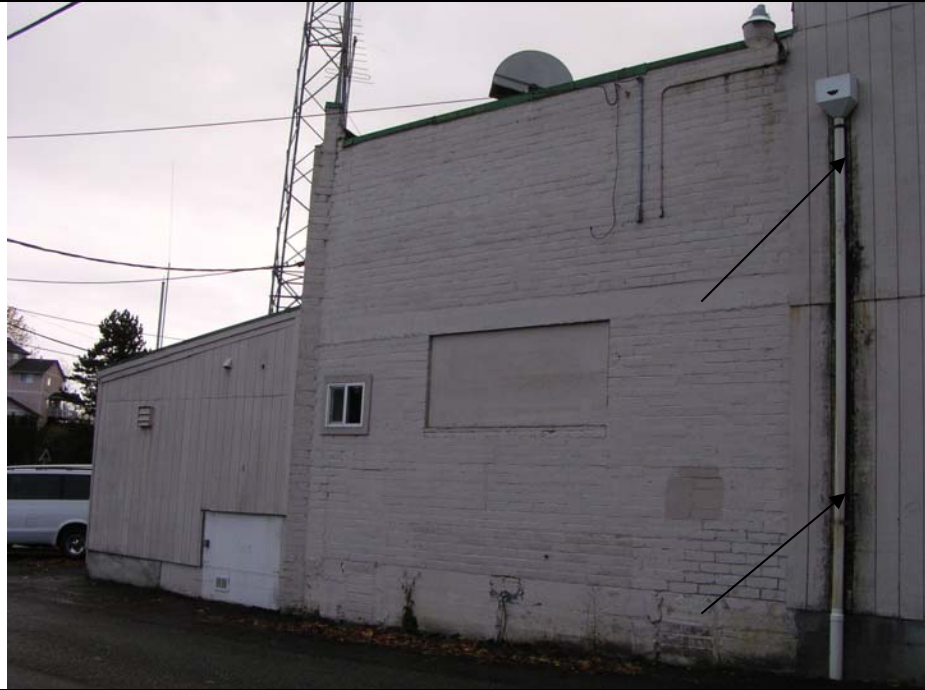
The east (front) and south side of building was stucco. The stucco had numerous cracks and was in need of paint. The west (rear) and a portion of the north side were T-111 wood panels. The panels were badly in need of paint and were rotting where the roof scuppers were attached. I suspect that there may be damage to the wall framing. I was not able to observe the suspect area from the interior. The balance of the exterior was painted block.

Exterior wall
rotting

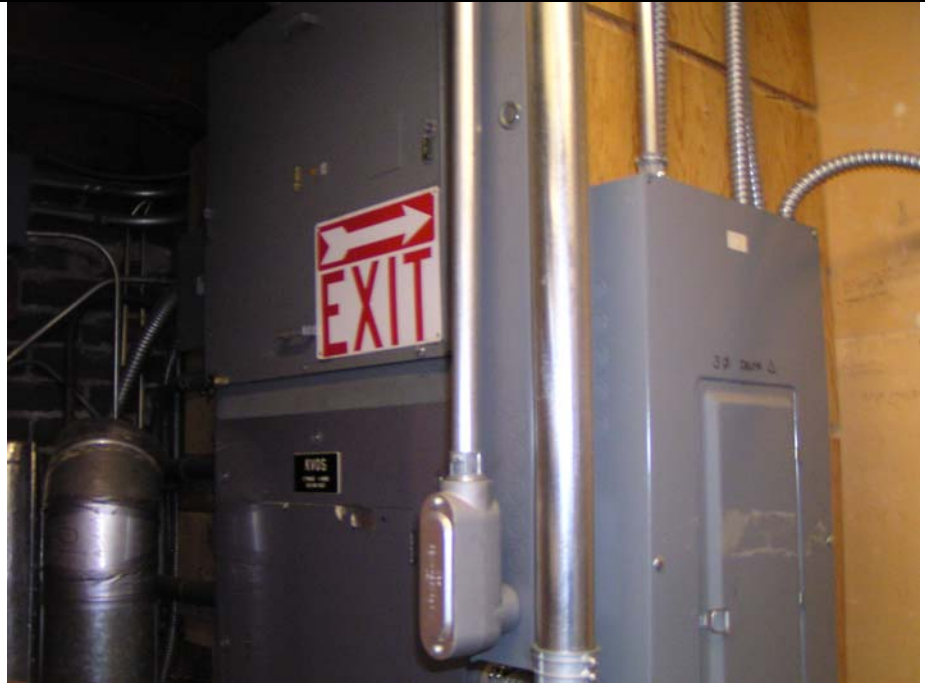
Main Electrical
Service

The electrical service comes in at the NE corner and is a 3 phase 4 wire 120-400 volt system. Amperage was unknown but most likely in the 400 amp range. The main electrical service panel was located in the attic. There were 17 distribution panels in various locations throughout the building. The building had a backup generator in a shed at the NE corner. The generator was a 30KW Alturdyne unit. It was fueled by a diesel tank underneath the antenna tower.

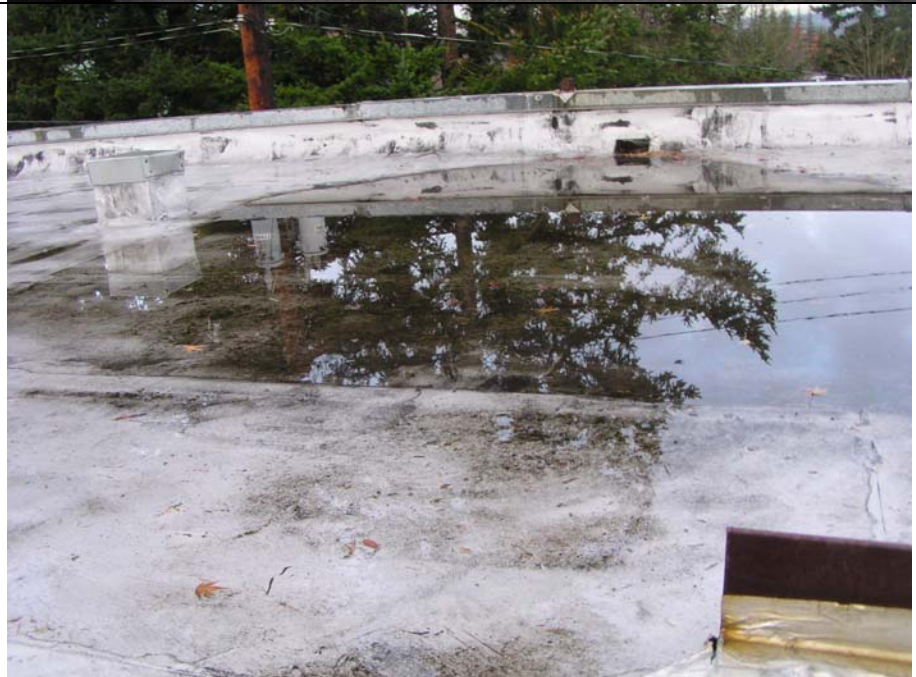
The roof was an older torch down membrane roof and rolled roofing. The deck is tongue and groove or plywood. It appeared to be well beyond its rated life of 10-15 years and had been silver coated at one time to extend its life. Based on conversations with Steve the roof has been continually leaking at the "walls." In our inspection I was unable to determine if the parapet walls were leaking at the flashing cap or at the membrane seams. The day prior to the inspection we had rain and most areas of the roof had ponding. In some areas there was ½" of standing water. Replacement costs will be higher due to the amount of equipment on the roof. A rough cost of replacement is \$40,000, however I would recommend that you get an accurate estimate from a roof company. Please let us know if you need a referral.

Roof
ponding water

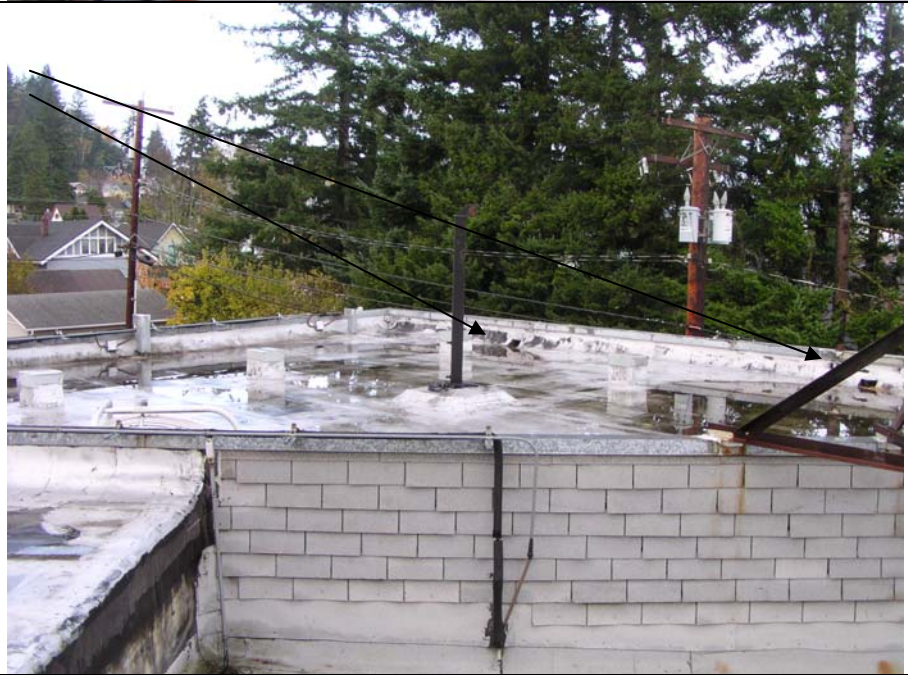
Roof –
Problematic
scuppers at right

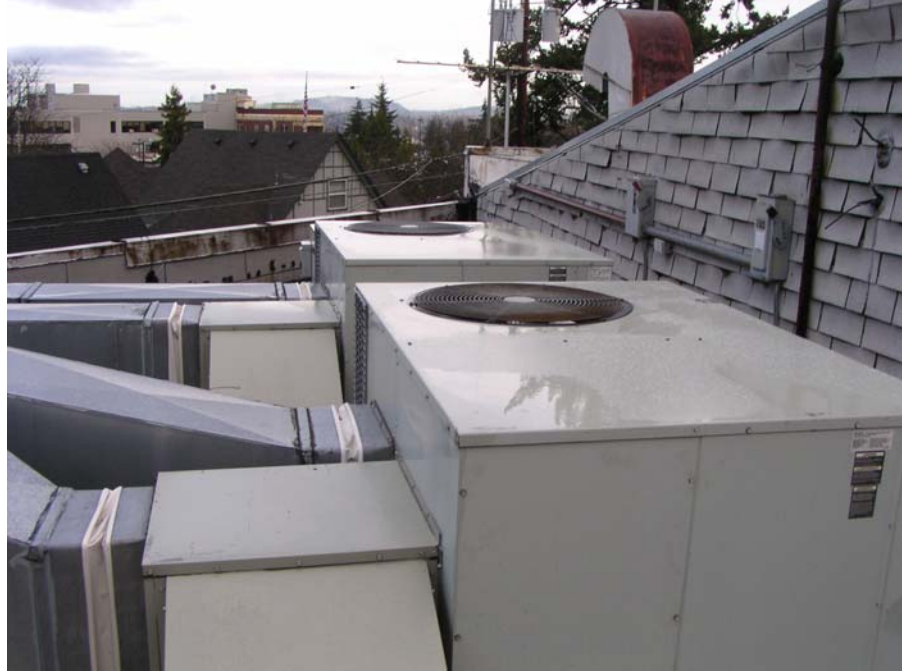
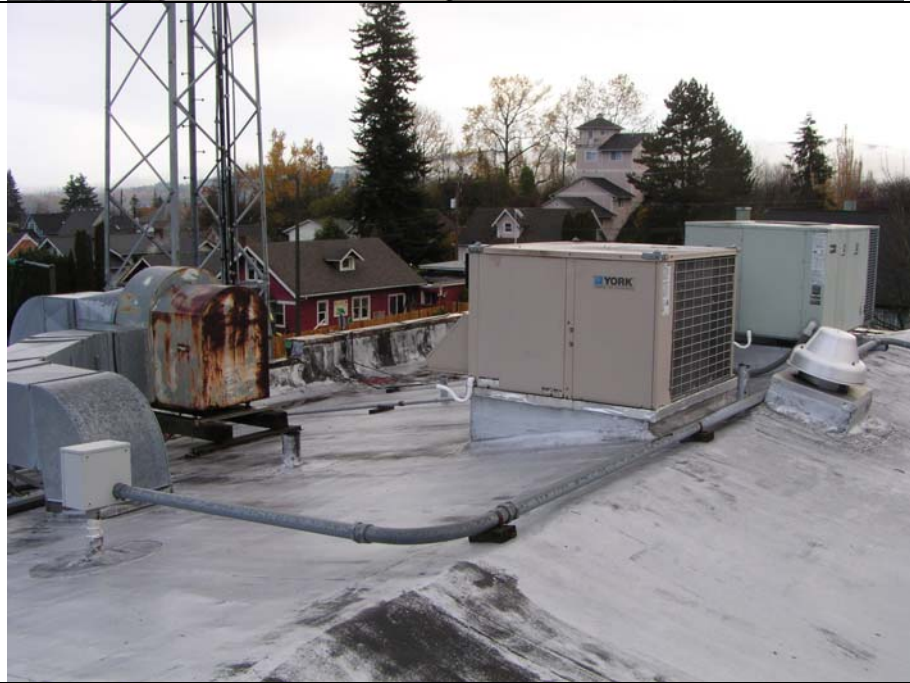
HVAC Units

Originally this building had conventional ducted HVAC packages on the roof. Some of these units have been removed and replaced with split ductless HVAC units. Currently there are 3 Trane roof packages that appear to be from the 80's and one York unit that is from the 90's.

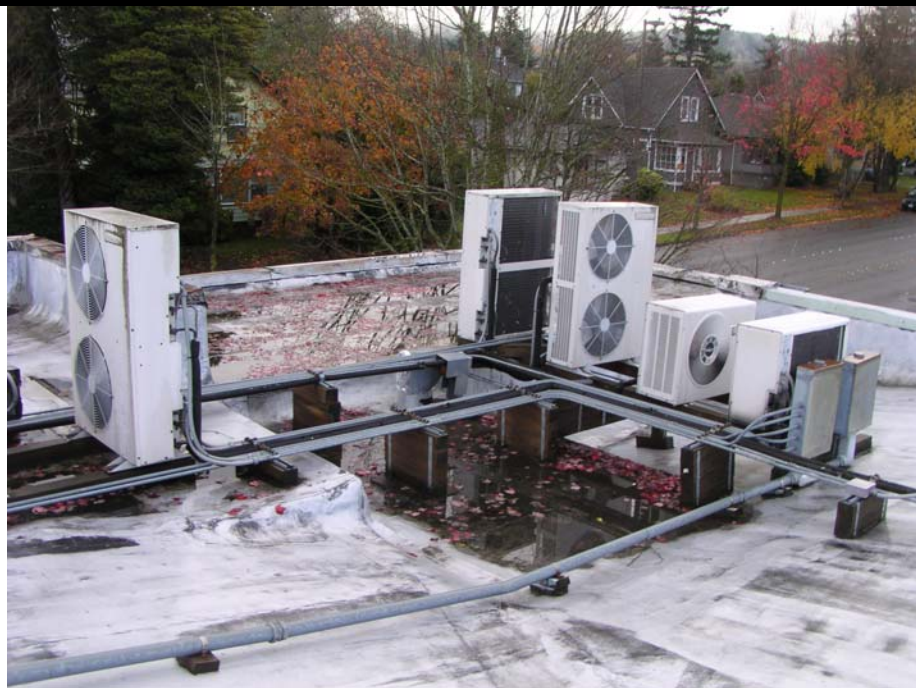
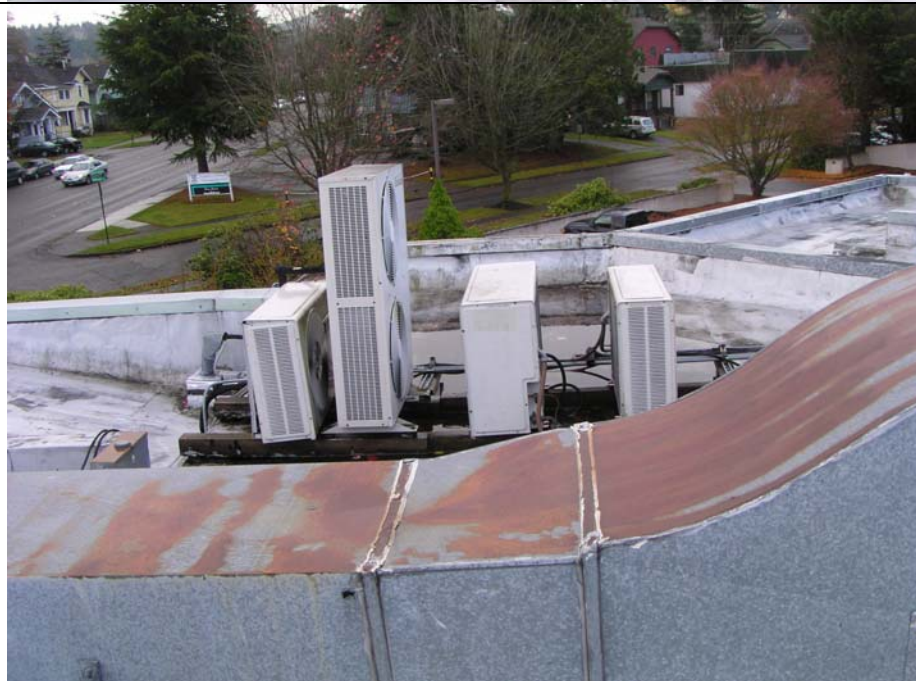
Split Systems

There were 21 split ductless heat pumps on the roof. 11 were newer Fujitsu and 10 were older Friedrich units. The Friedrich units need to be replaced as they do not perform well at temps under 40's. When the temperature drops under 40 degrees the heat pump activates a heat strip to warm the air. Newer heat pumps (such as the Fujitsu's) continue to deliver heat until temperatures drop to 25 degrees, then will turn on a heat strip. I observed that most of the occupied offices had portable heaters. Cost to upgrade the Friedrich units was \$3,500 apiece.

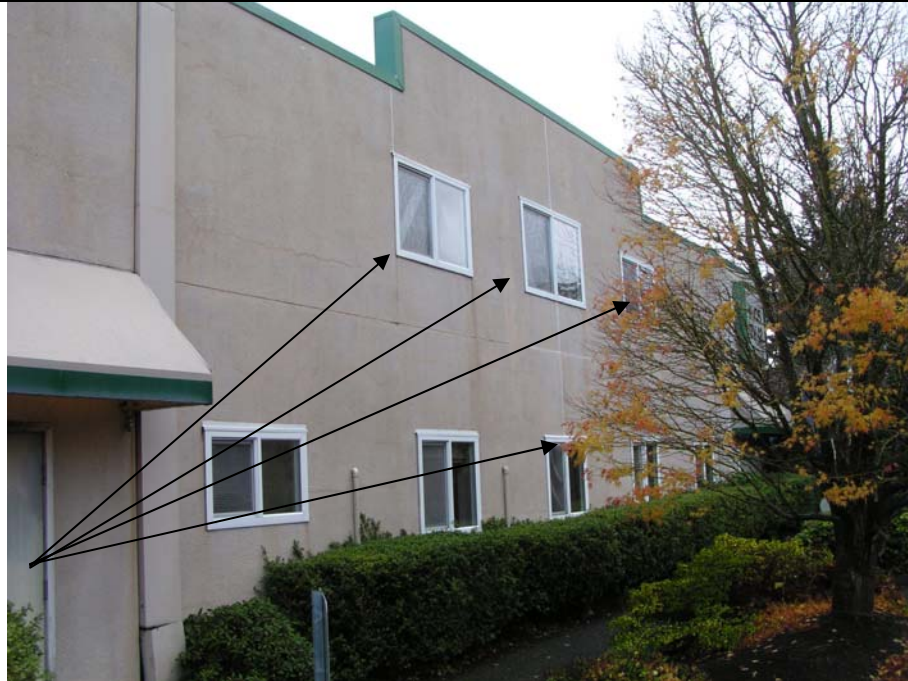
The windows were aluminum framed commercial grade at the front and vinyl windows on the south side. The windows overall have been a source of continual leaks in this building. Most likely the windows were not flashed properly and numerous attempts have been made to fix the installation. According to Steve when they get a driven rain, leaks develop. At the time of inspection there were no leaks observed.

windows with
problem

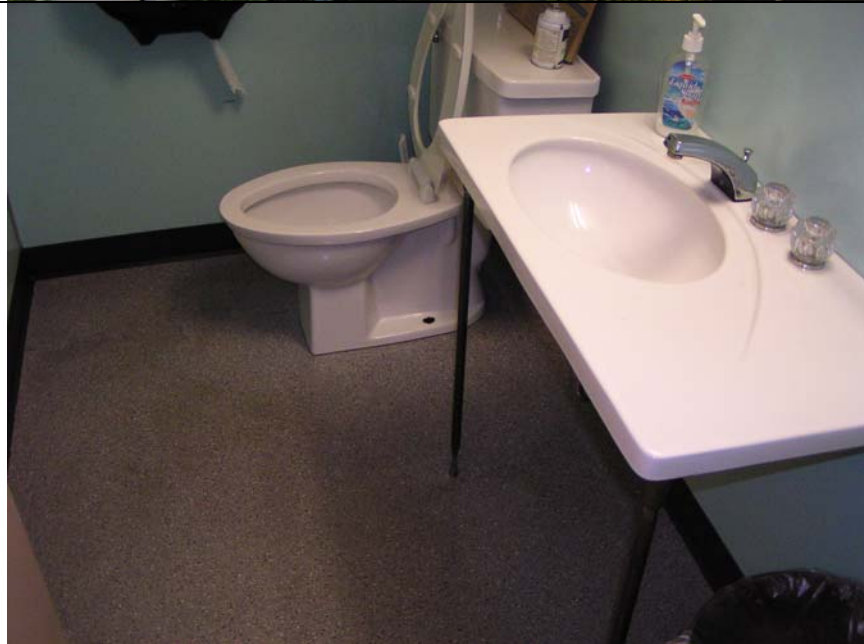
Bathrooms

The bathrooms were single commode units and very dated.

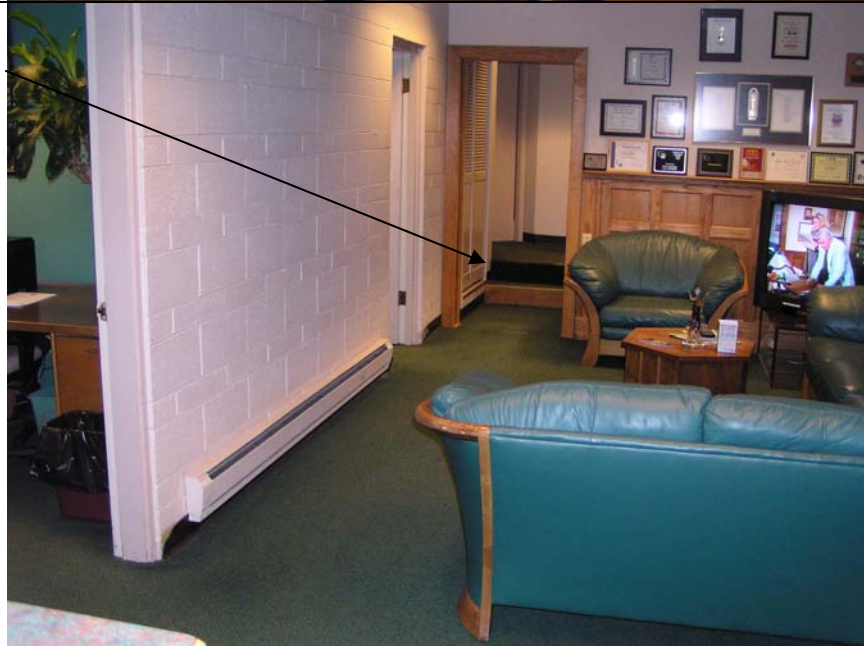
This building had two handicap parking spots. The main entrance is not handicap accessible due to the door handle. Steps prevent anyone with a wheel chair from accessing offices from the lobby. The bathrooms are not handicap accessible and interiors not handicap compliant. The offices on the first floor can be reached without using stairs by using one of the rear entrances but that entrance is not designated with a sign.

Lobby
Note steps
