Inspection Report

on
555 29th Street,
Anacortes, WA

April 23, 2006

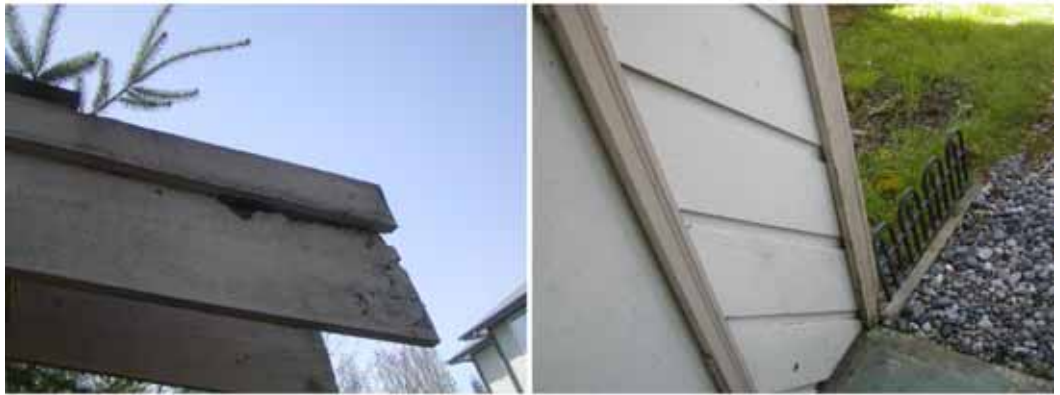
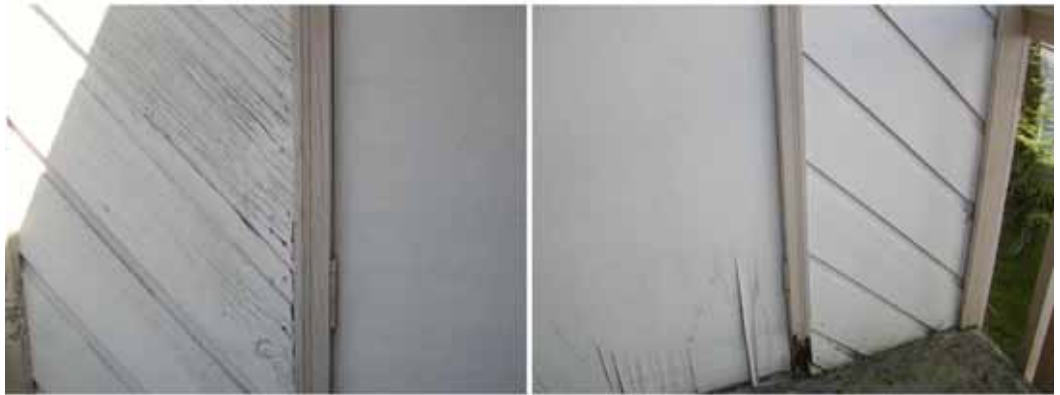
Paint was peeling and wood rot was found in numerous trim areas. The storage areas on units 8 & 9 had rot on the storage areas. None of this was extensive or involving the structural elements of the building

Paint was peeling and wood rot was found in numerous trim areas. The storage areas on units 8 & 9 had rot on the storage areas.

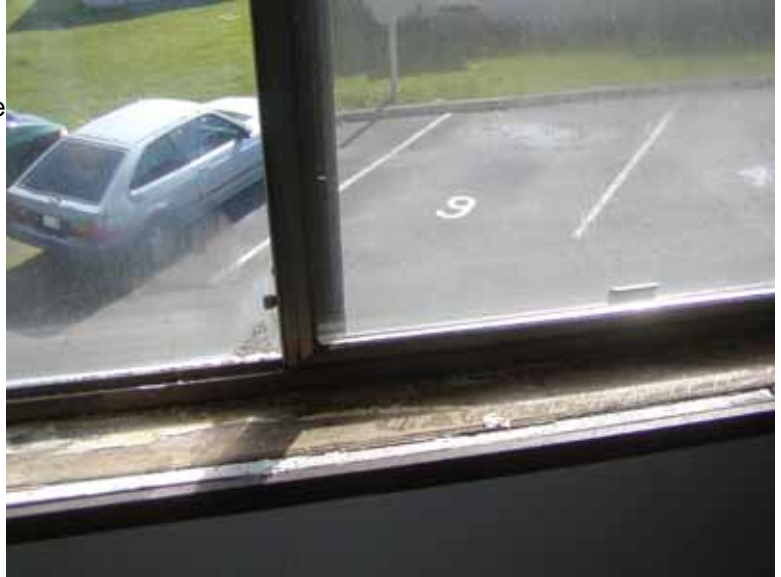
Poor - condensation seen in most of the windows inspected - recommend replacement. Many of the windows were missing screens.

Wood. Some of the window sills had damage from condensation and have been repaired or in the process of being repaired.

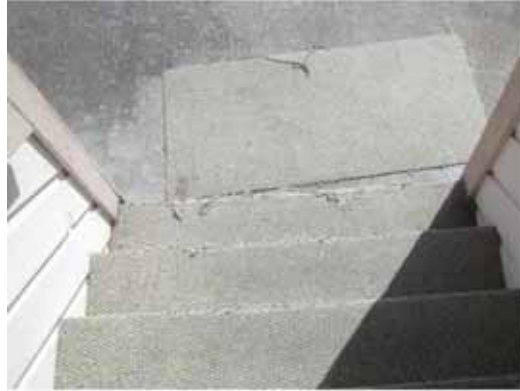
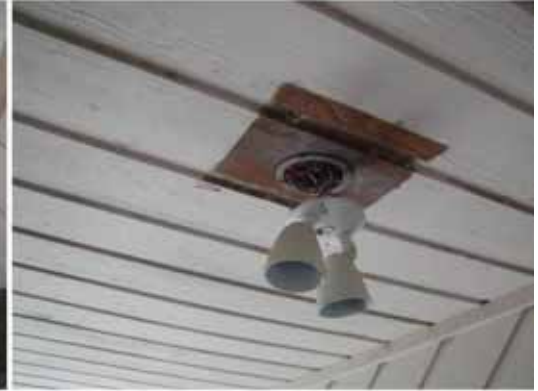
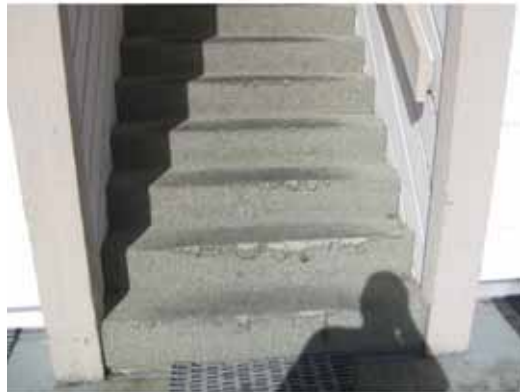
1. The carpeting on the stair is worn, torn and a trip hazard - replace - safety issue. The lights are the top of the stairs was either missing or damage - replace fixtures.

The carpeting on the stair is worn, torn and a trip hazard - replace - safety issue. The lights are the top of the stairs was either missing or damage - replace fixtures.

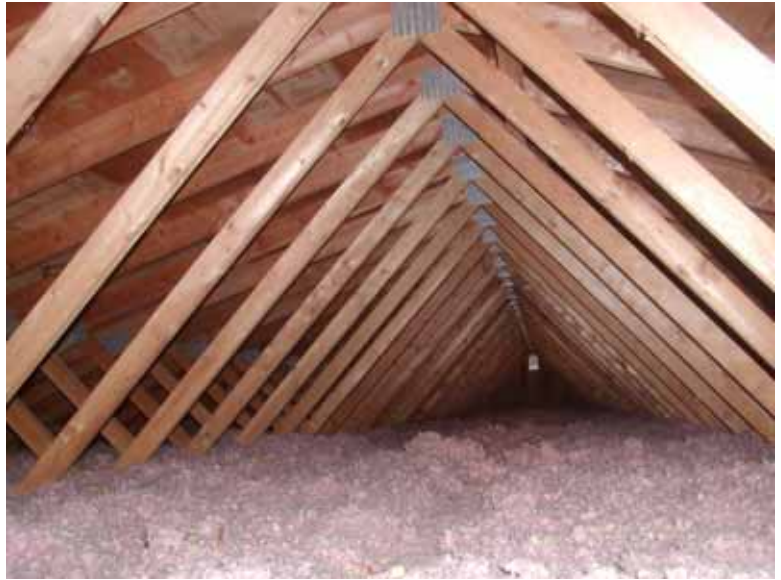
Gabled.
2x6 manufactured truss.

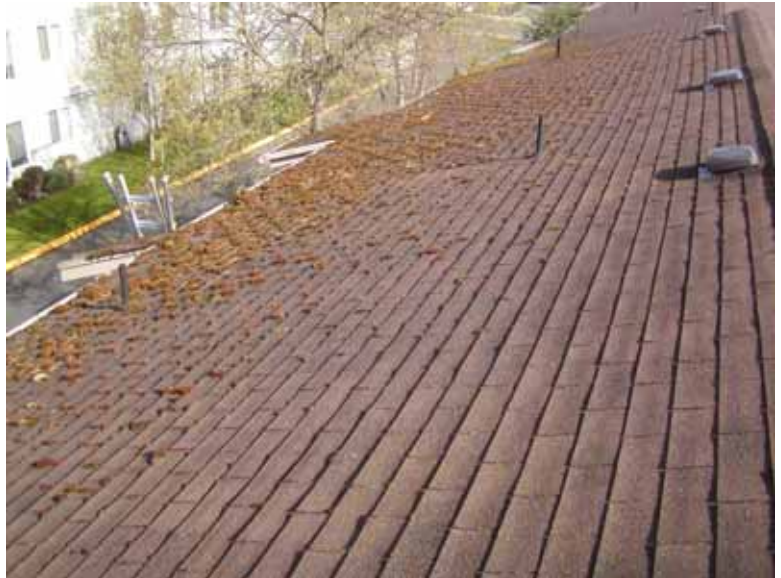
3. Good. - Remove buildup of moss from roof and consider adding zinc strips. It appears that this roof has multiple layers installed.

Plywood.
Fiberglass shingles.
Good. - Remove buildup of moss from roof and consider adding zinc strips. It appears that this roof has multiple layers installed.

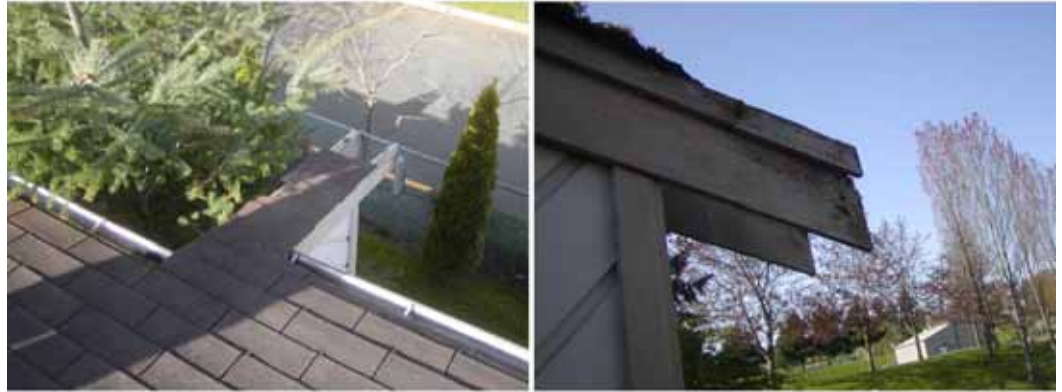
Wood/Wood - Most of the rafter tails on the east side have some level of rot/deterioration cut back and add flashing as needed.

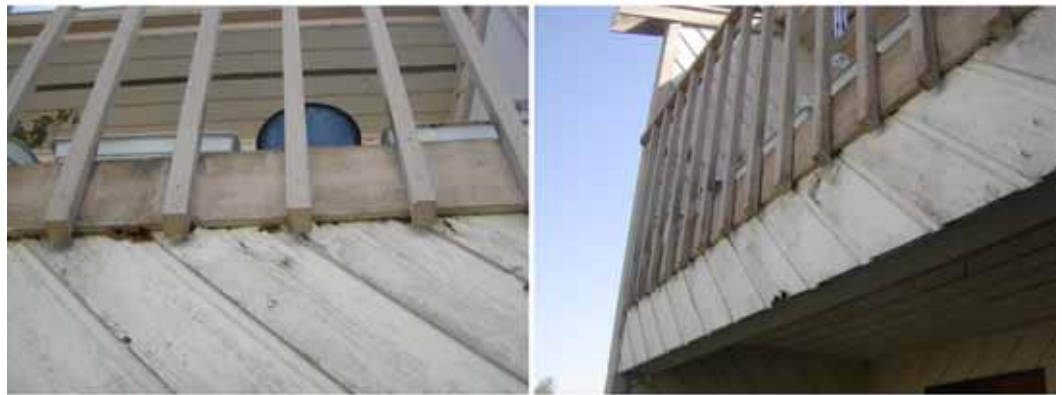
The 2nd floor patio areas appear to drain onto the wooden siding. This is problematic and the effect of long term moisture exposure was obvious. A drainage system for these decks is needed before new siding gets installed.

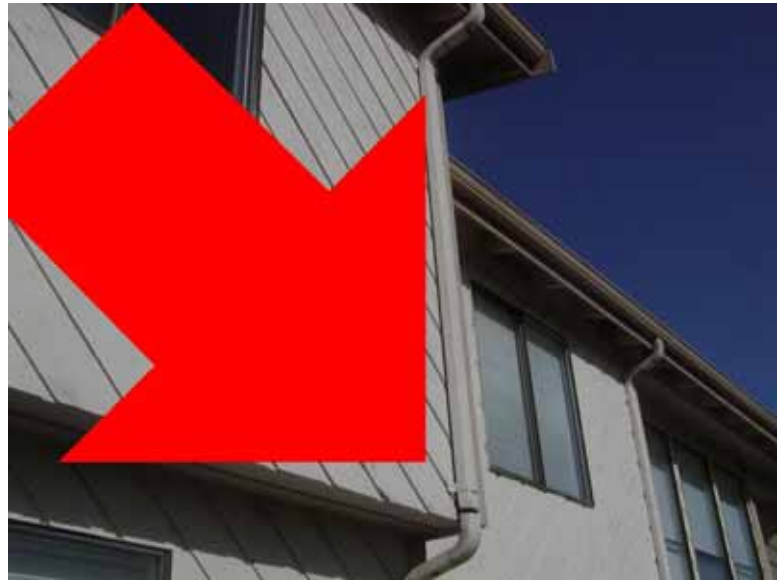
4. Downspout disconnected in front. 2) Debris in gutters - repair and cleanout.

Downspout disconnected in from.
2) Debris in gutters - repair and cleanout.

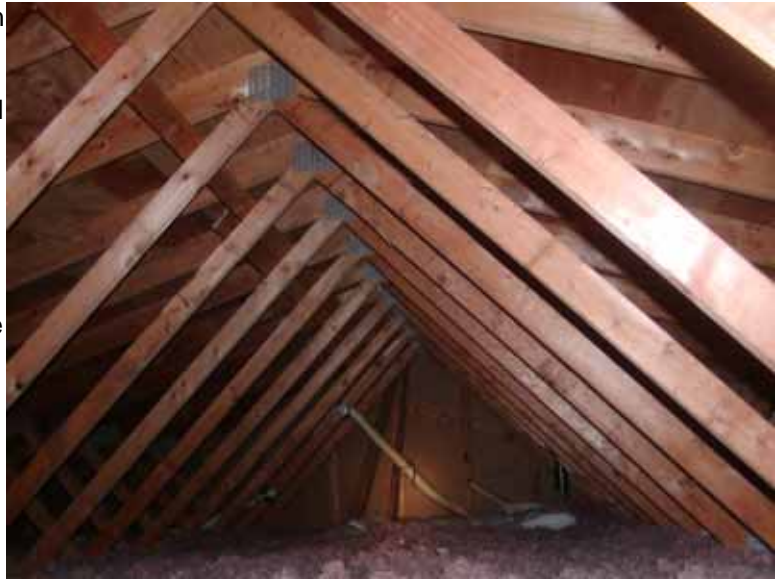
VENTING- The bathroom vents on the second floor universally were not vent to the exterior and most outlets were buried in the fiberglass rendering them useless. These fans need to be vented to the exterior preferable with hardwall pipe. 2) There were several dryer connections seen from the center attic access (units 9-10) that appeared to be using plastic hose which had failed. This is problematic for two reasons. Plastic hose has a high air resistance and is only appropriate for short runs within home and in the event of a fire will allow the fire into the attic area. Replace with solid wall vent pipe

The bathroom vents on the second floor universally were not vent to the exterior and most outlets were buried in the fiberglass rendering them useless. These fans need to vented to the exterior preferable with hardwall pipe. 2) There were several dryer connection seen from the center attic access (units 9-10) That appeared to be using plastic hose which had failed. This is problematic for two reason. Plastic hose has a high air resistance and is only appropriate for short runs within home and in the event of a fire will allow the fire into the attic area. Replace with solid wall vent pipe.

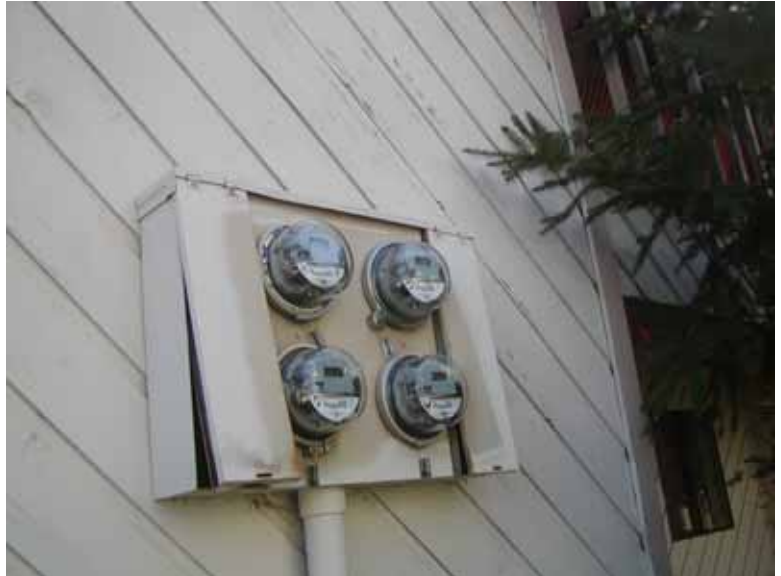
- Location of Service Disconnects:
2. Panel covers should be secured. Safety issue.

Rear exterior of building - **Panel covers should be secured. Safety issue.**

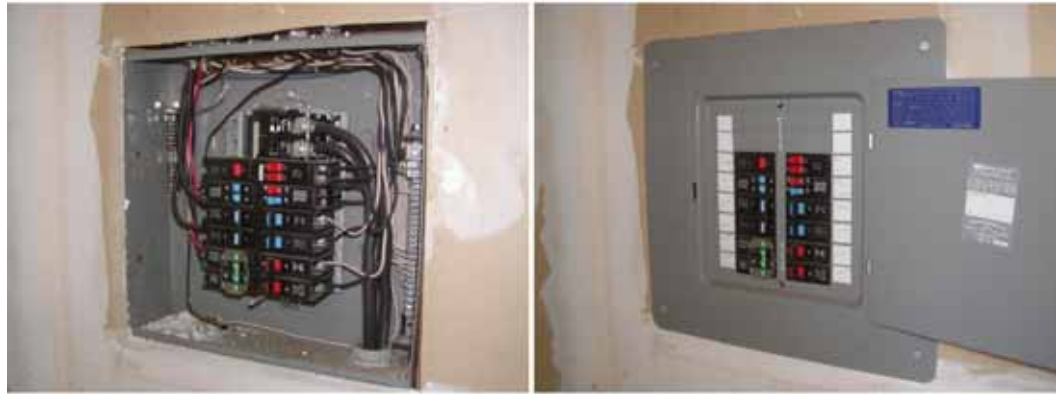
In exterior storage closets.

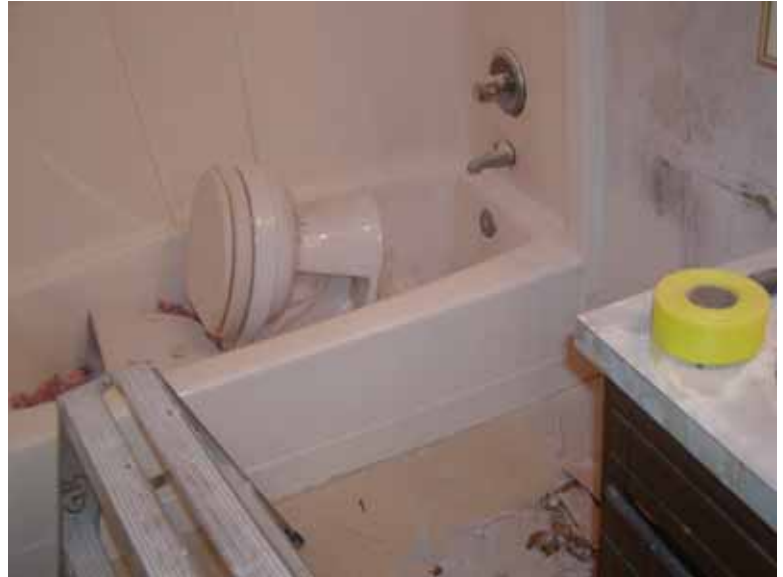
Being Renovated.

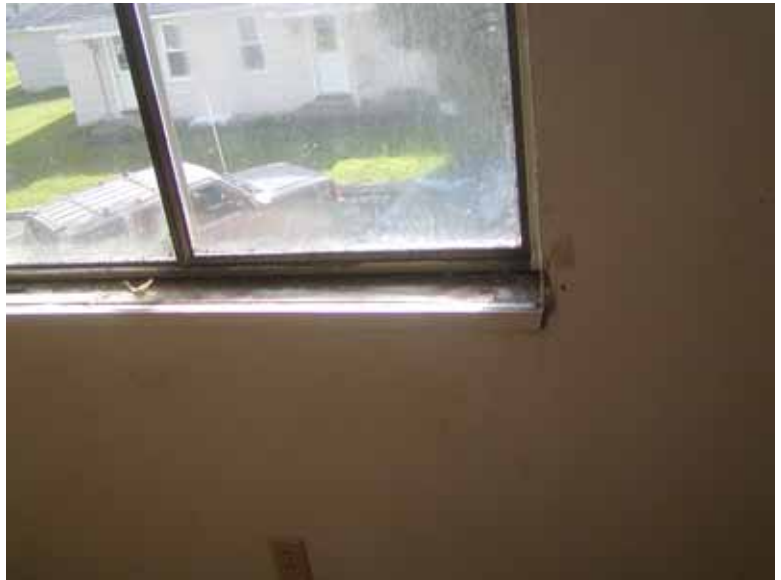
- Walls:** Fair overall condition.
- Ceilings:** Fair overall condition.
- Floors:** Carpet is only in fair to poor condition.
- Windows:** Condensation found in all windows - one cracked.

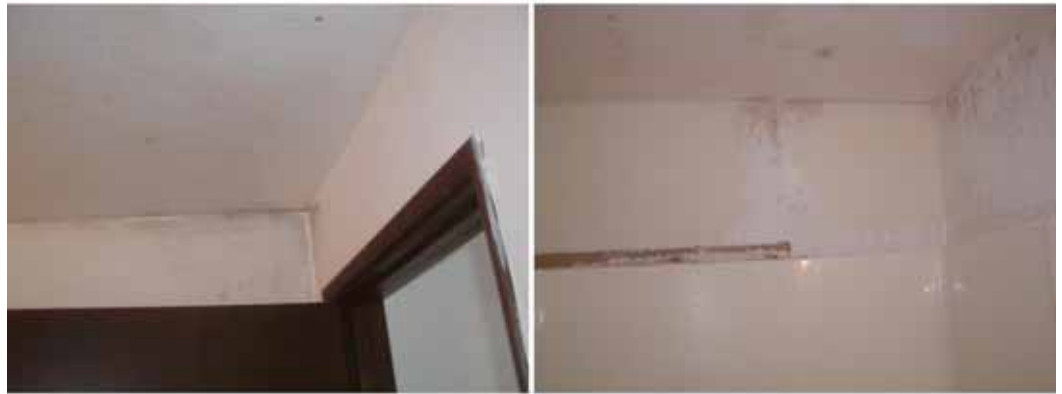
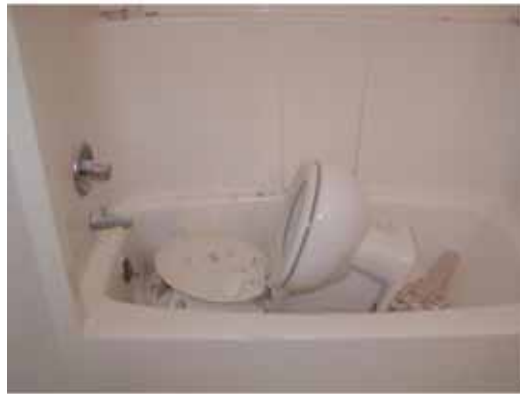
5. Mold/Mildew on walls. These areas should be treated to ensure that the issues do not return.

Mold Mildew on walls. These areas should be treated to ensure that the issues do not return.

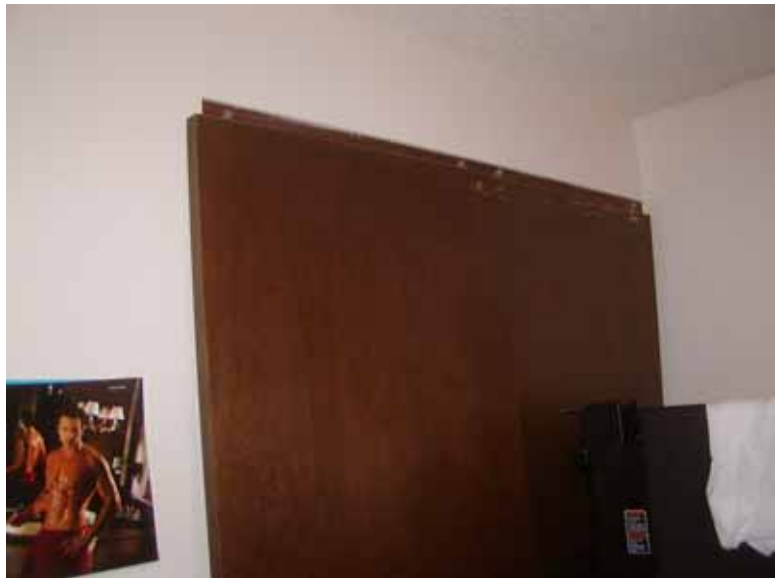
Closets: Bedroom closet doors were unattached - remount.

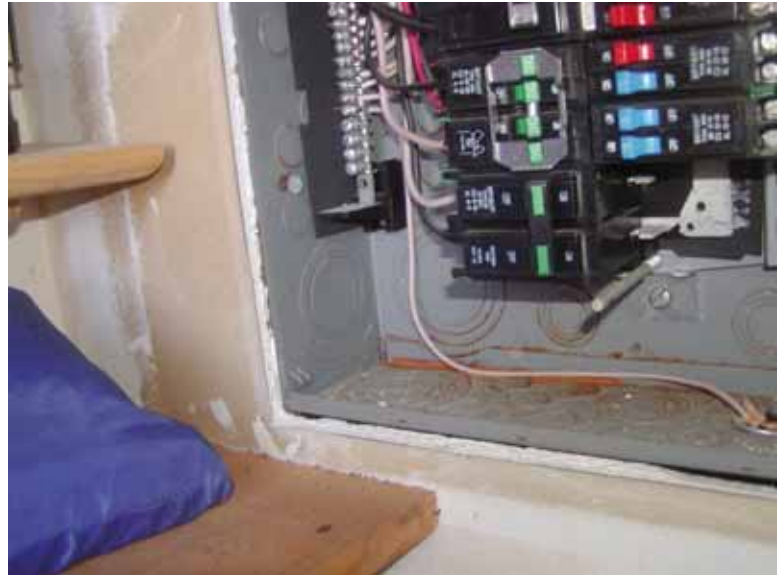
10. Evidence of water in box - reseal conduit flashing.

Evidence of water in box - reseal conduit flashing.

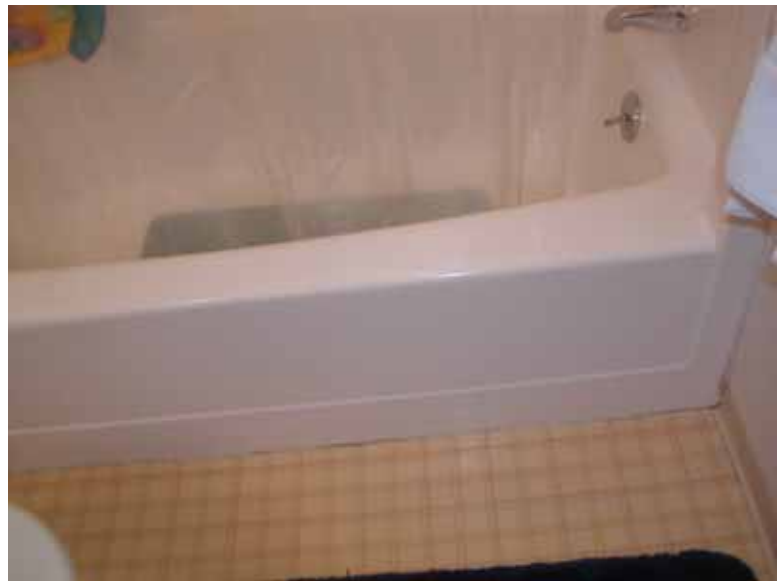
11. reseal around tub.

reseal around tub.

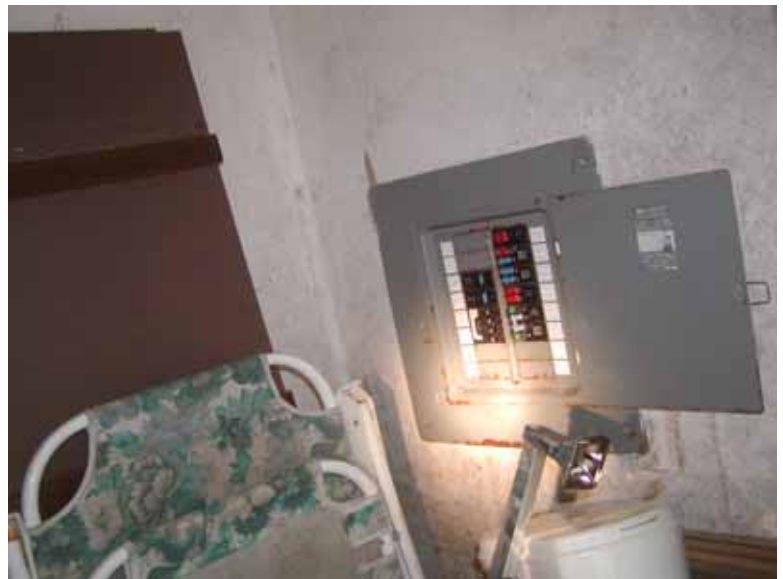
12. Water appears to be leaking into panel - repair.

Water appears to be
leaking into panel -
repair.

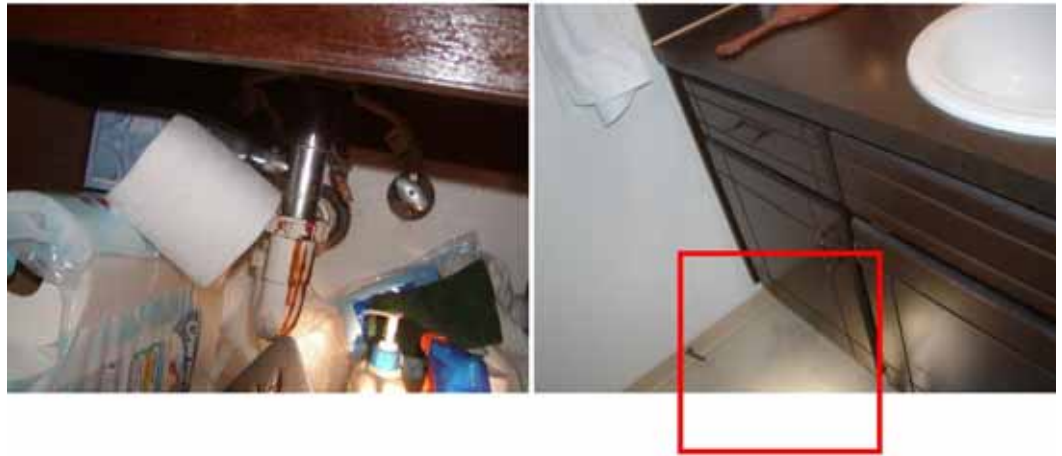
Sink appeared to be leaking at one time.

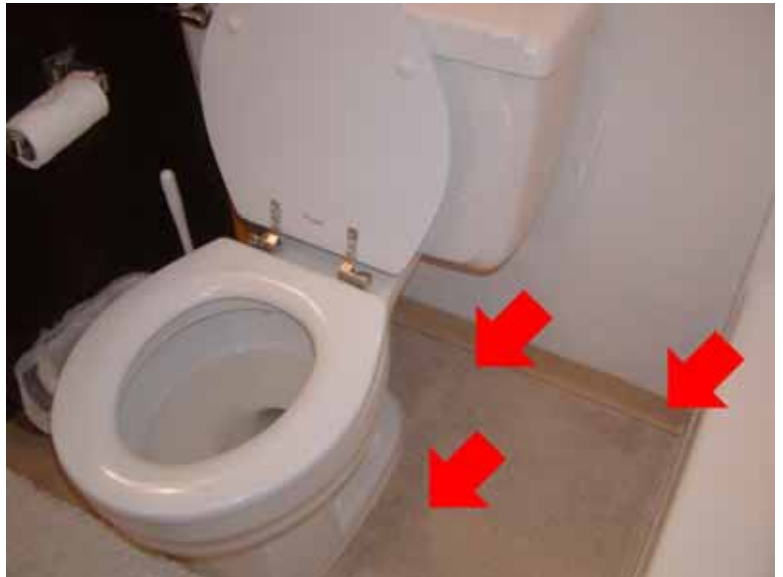
Toilet is loose at the floor. Leakage is detected in the surrounding floor area.

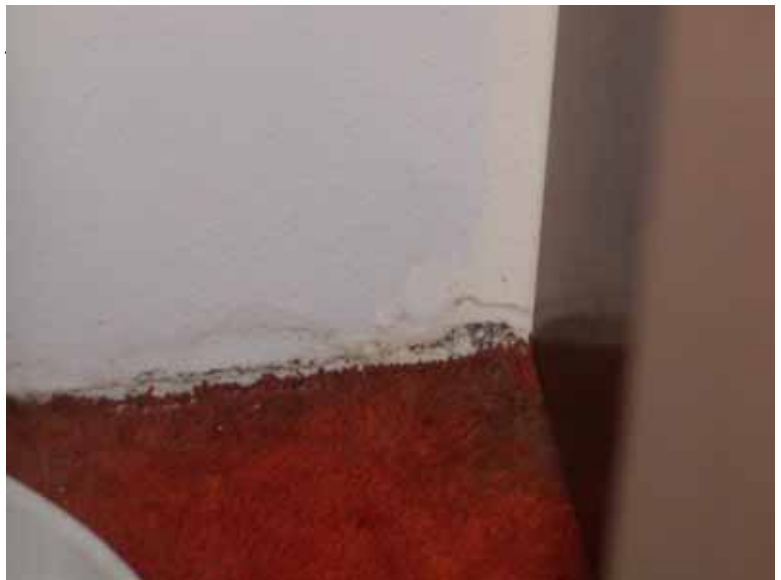
Water damage to washing machine area
replace sheetrock.

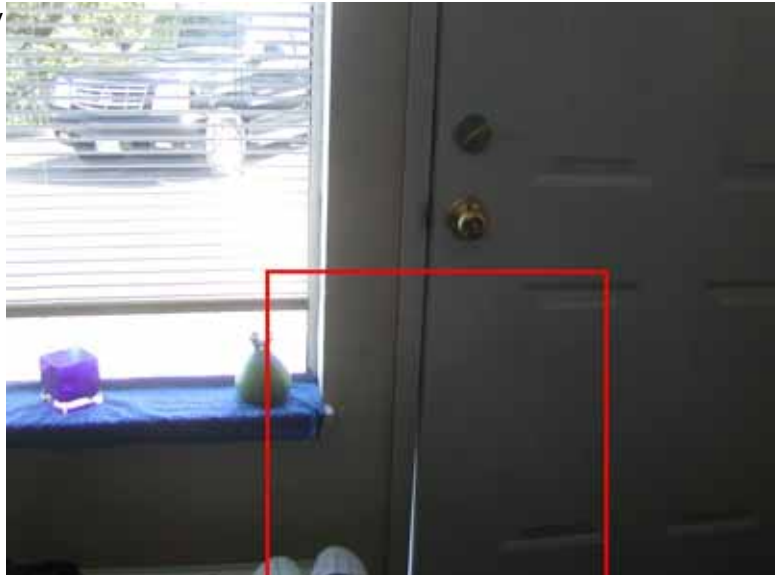
Door does not fit tightly
adjsut or add weather
stripping.

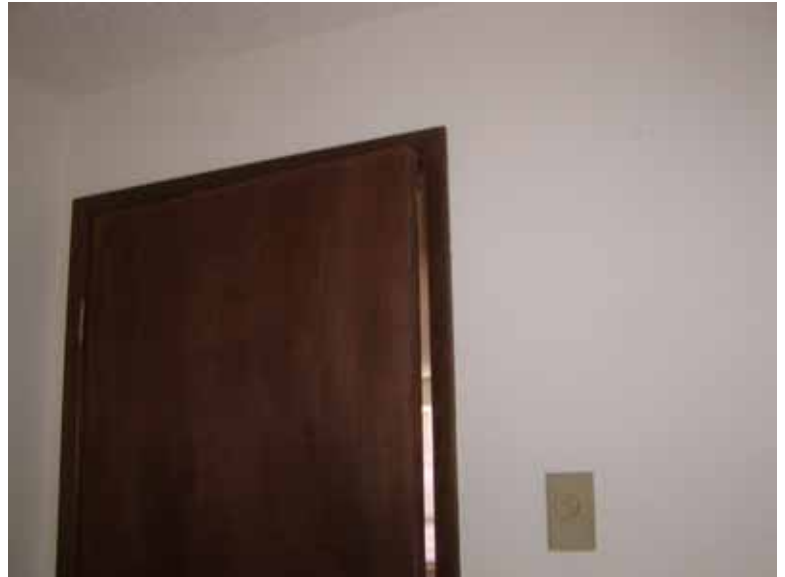
13. Bedroom door would not close - adjust or trim.

Bedroom door would not close - adjust or trim.

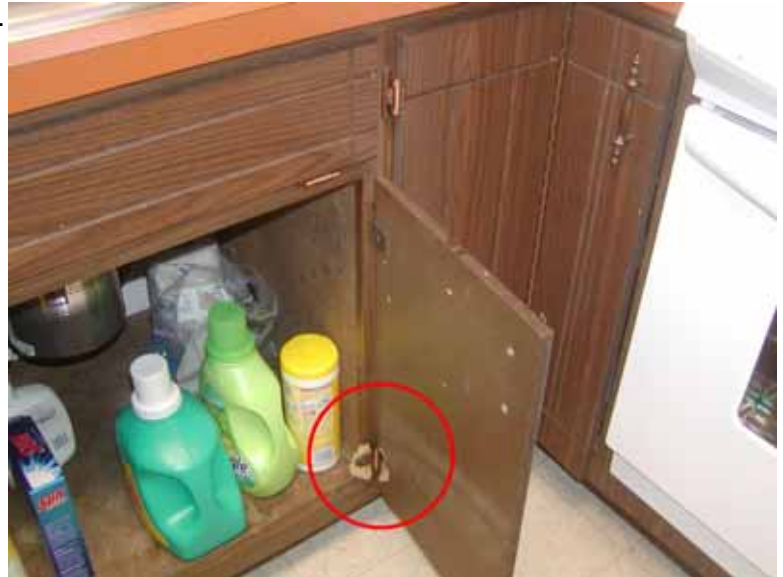
15. Sink cabinet door had hinge broken off - repair.

Sink cabinet door had hinge broken off - repair.
