Inspection Report
For
1151 Ellen St.
Seattle, Washington

Commercial Inspection Report
For
1151 Ellen St.
Seattle, Washington

Date: November 19, 2011
Type of Property: Commercial Two Story Building
Weather: Overcast, Rain

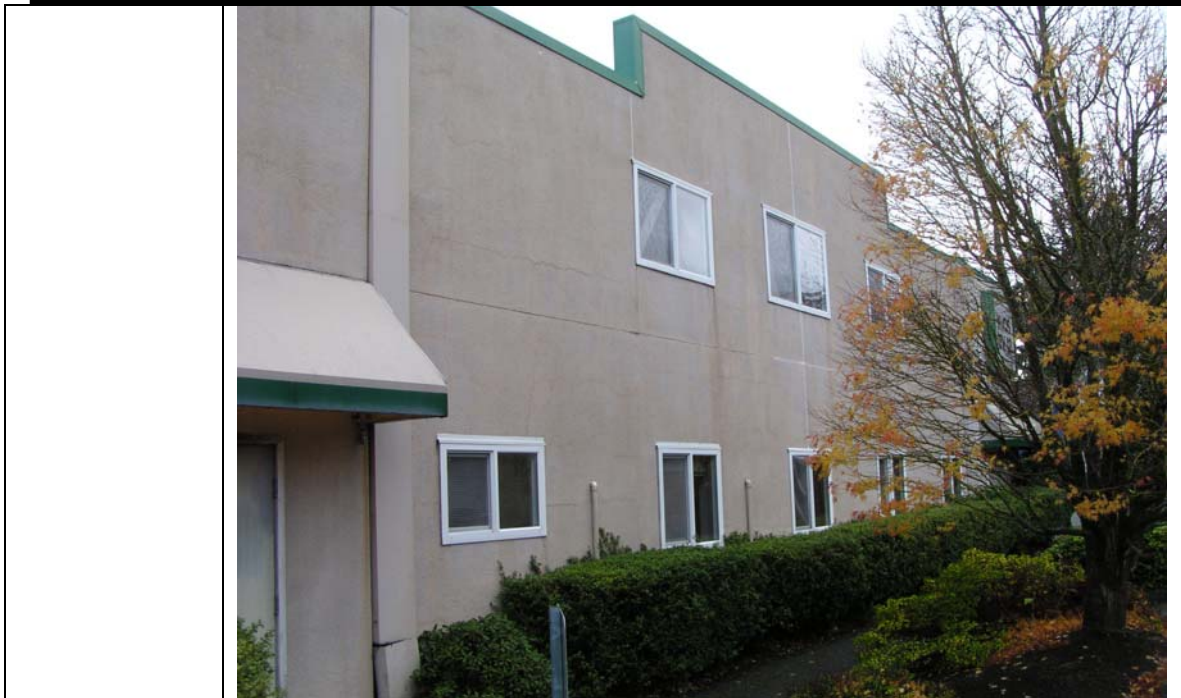
Exterior Rear

The east (front) and south side of building was stucco. The stucco had numerous cracks and was in need of paint. The west (rear) and a portion of the north side were T-111 wood panels. The panels were badly in need of paint and were rotting where the roof scuppers were attached. I suspect that there may be damage to the wall framing. I was not able to observe the suspect area from the interior. The balance of the exterior was painted block.

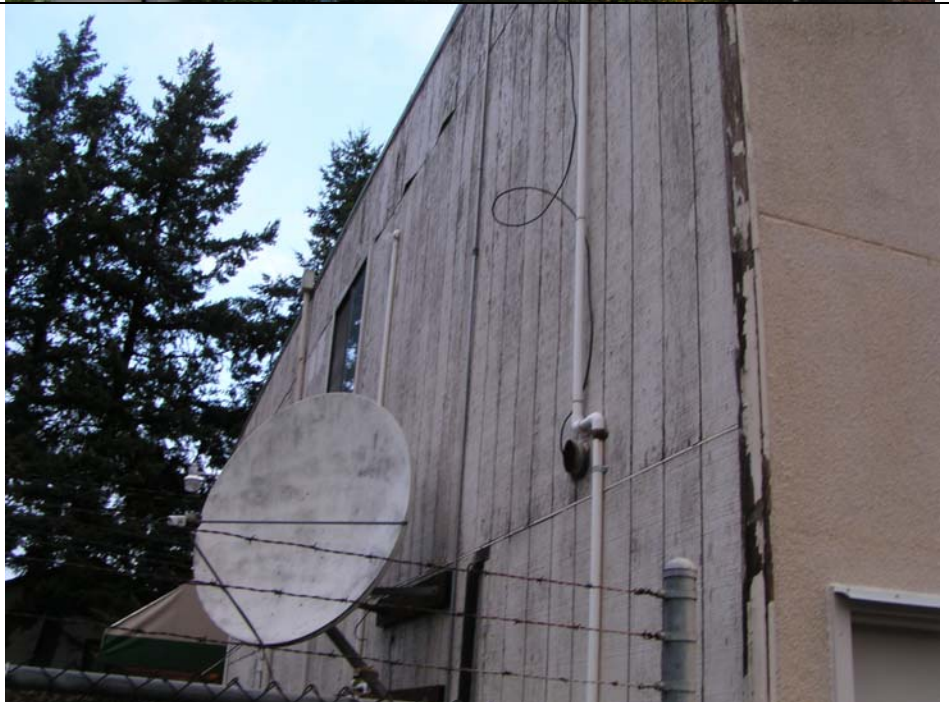
Exterior wall
rotting

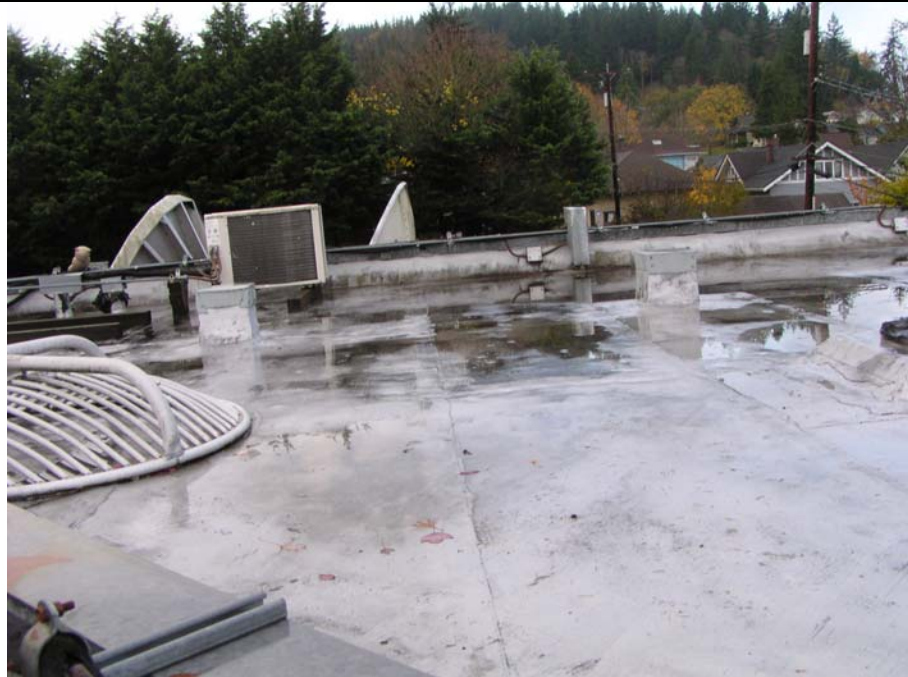
Roof –
Problematic
scuppers at right
